ONE AND TWO WORLD TRADE CENTER
Structural Integrity Inspection

Accessible Columns

LERA Job. 1133902
PA Job. W2 702.302

17 May 1996

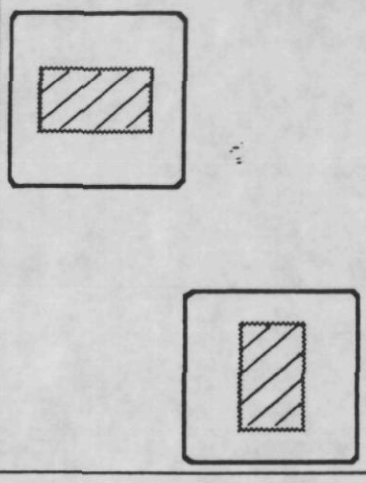
ITEM: 1 (Sheet 1 of 6)	URGENCY: Routine	Location of Finding
LOCATIONS: Columns in elevator shafts in 1 & 2 WTC **FINDING:** Deterioration of fireproofing Exposed steel with light to moderate surface rust **RECOMMENDED ACTION:** Repair fireproofing per Appendix E

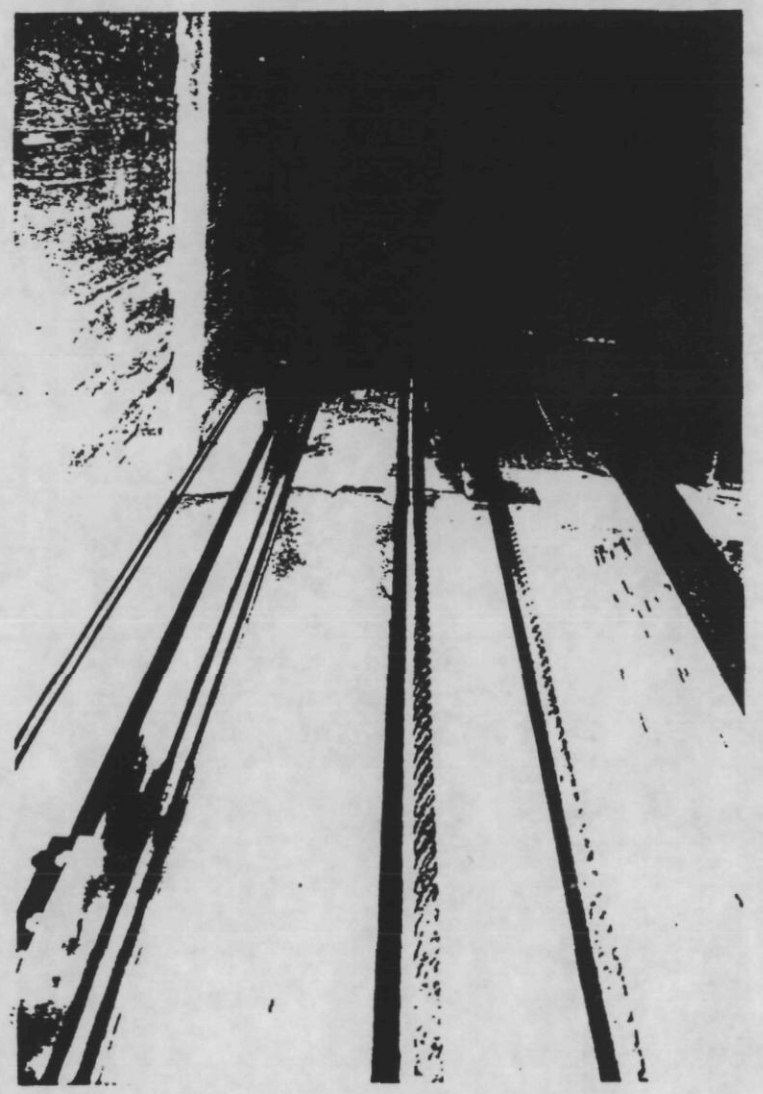
Col. 603

Floor 26 looking up Similar condition at floor 27, 28,43, 56

Exposed steel on column and connecting beams
Light rust

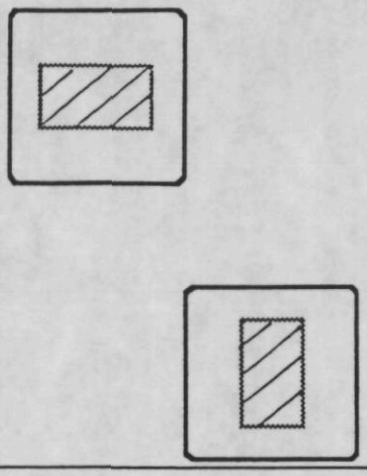
ITEM: 2 (Sheet 1 of 2)	**URGENCY: Routine**	**Location of Finding**
LOCATIONS: Columns in elevator shafts in 1 & 2 WTC **FINDING:** Exposed steel on column at guide rail angles Drilled holes from previously placed angles **RECOMMENDED ACTION:** Repair fireproofing per Appendix E

- fireproofing removed for guide rail angles
- exposed steel with light rust
- drilled holes from removed clip angles

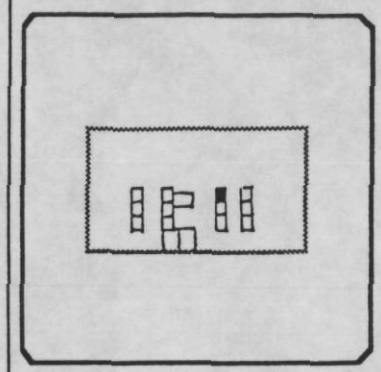
ITEM: 3 (Sheet 1 of 1)	**URGENCY: Routine**	**Location of Finding**
LOCATIONS: 1WTC - Col. 706 Elev. Shaft 95A Floor 100 **FINDING:** Exposed steel at damaged drywall cant with light surface rust **RECOMMENDED ACTION:** Repair drywall cant per Appendix E, SK - 1

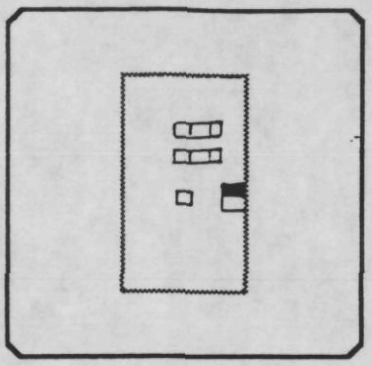
PHOTOGRAPHS:
Photo 31

ITEM: 4 (Sheet 1 of 1)	URGENCY: Routine	Location of Finding
LOCATIONS: 2WTC - Col. 904 Elev. Shaft 6B Floor 105 **FINDING:** Exposed web of column **RECOMMENDED ACTION:** Enclose with fireproofing material, Structolite or equivalent, providing a cant of 75° angle at the column transition, per Appendix E, SK - 1

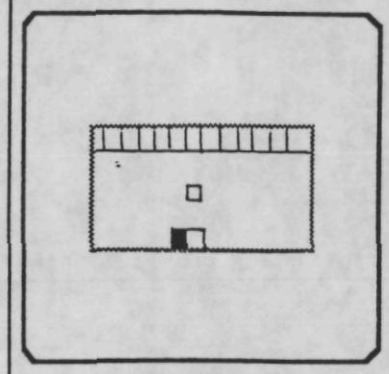
PHOTOGRAPHS:
Photo 3

ITEM: 5 (Sheet 1 of 1)	**URGENCY: No Action**	**Location of Finding**
LOCATIONS: 1WTC - Col. 903 Elev. Shaft 7A Floor 76 **FINDING:** Apparent water damage; Appears dry and adhesion/cohesion appears in good condition **RECOMMENDED ACTION:** No action

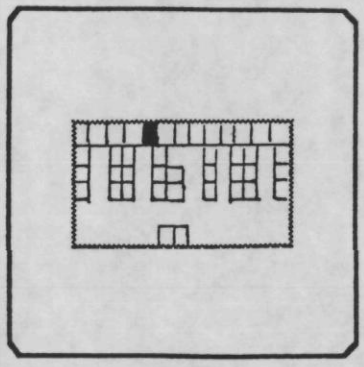
FINDING:
Damage to fireproofing due to compensation cable
No exposed steel

RECOMMENDED ACTION:
No action

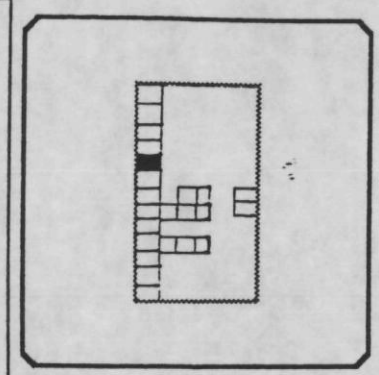
FINDING:
Exposed erection bolt at column

RECOMMENDED ACTION:
No action

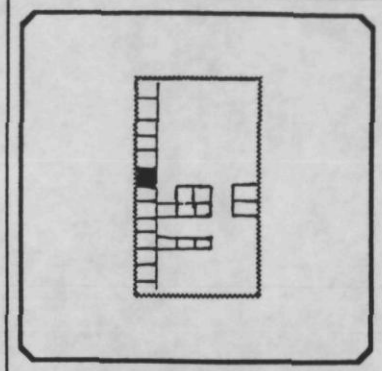
FINDING:
Damage and cracking of fireproofing
No exposed steel

RECOMMENDED ACTION:
No action

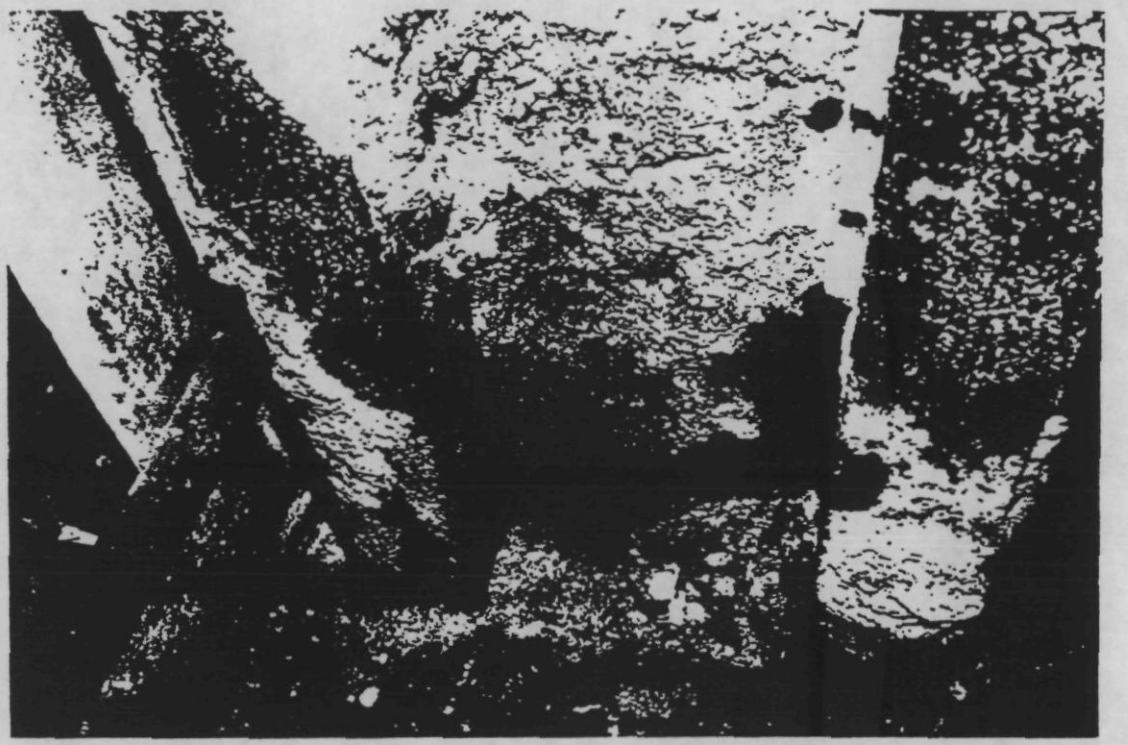
Photo 22	1WTC	Shaft 69A	Floor 43	Col. 802	Exposed column and splice Deterioration fireproofing at base of *column* Moderate to heavy rust Bolt heads at splice rusting

ITEM: 10 (Sheet 1 of 2)	**URGENCY: Routine**	**Location of Finding**
LOCATIONS: Elevator pits in 1 & 2 WTC **FINDING:** Exposed steel at column base with moderate surface rust and exposure continuing to floor below Moderate surface rust at the underside of flange on the partially embedded elevator beams **RECOMMENDED ACTION:** Repair fireproofing per Appendix E Enclose area of web at floor level with fireproofing Clean and paint elevator beams with zinc rich paint

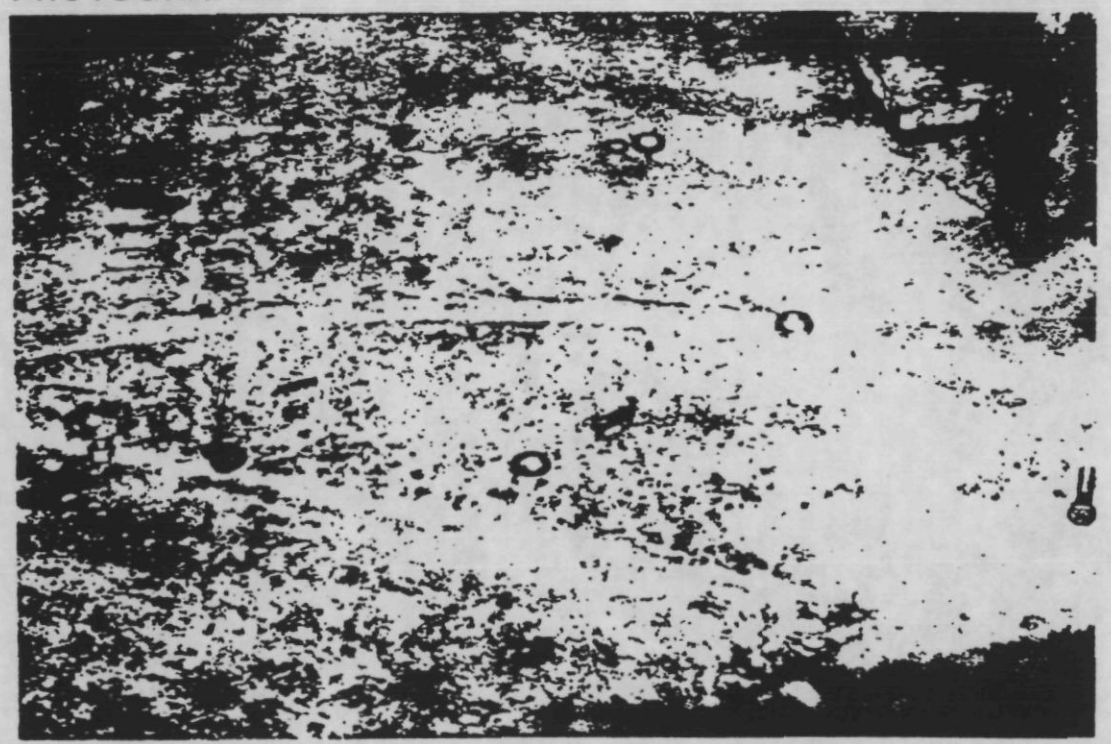
FINDING:
Rough surface condition at top of slab

Photo 68	2WTC	Shaft 95B	Floor 77	Col. 706	Rough slab surface

RECOMMENDED ACTION:
No action

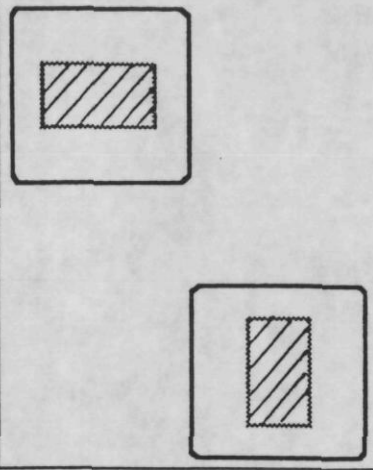
ITEM: 12 (Sheet 1 of 6)	URGENCY: Routine	Location of Finding
LOCATIONS: Connecting beams to columns in elevator shafts of 1 & 2 WTC **FINDING:** Exposed steel at webs and flanges of connecting beams **RECOMMENDED ACTION:** Repair fireproofing per Appendix E

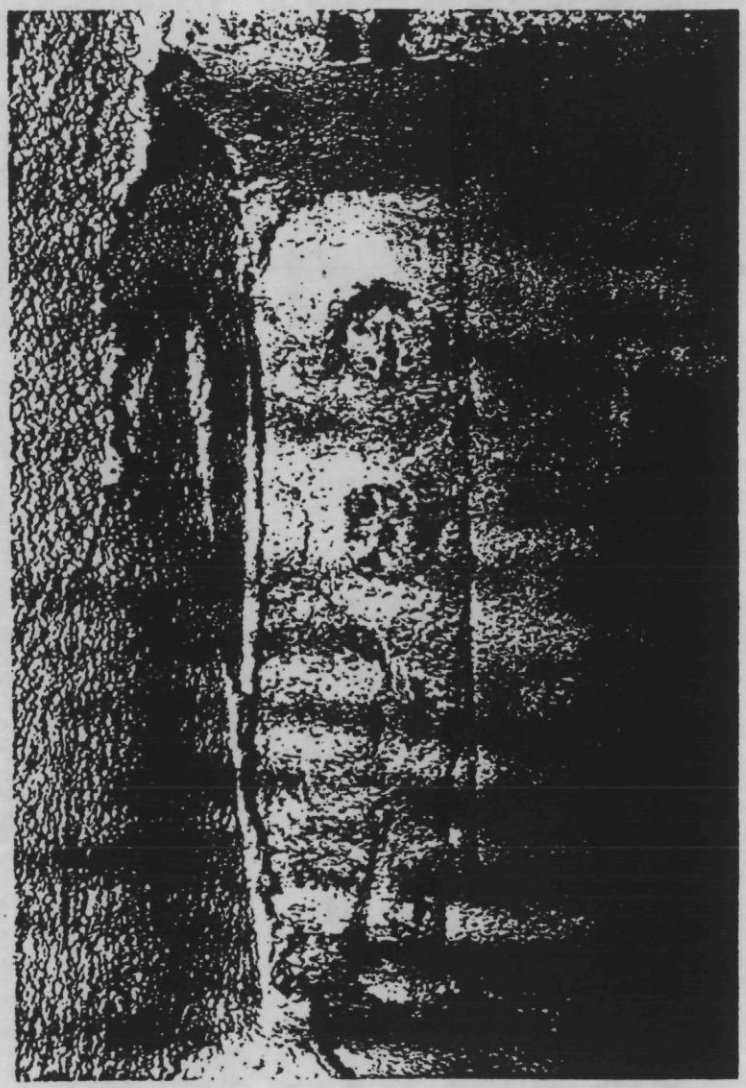
Col. 706

Deterioration of fireproofing exposing bolts heads on connecting beams

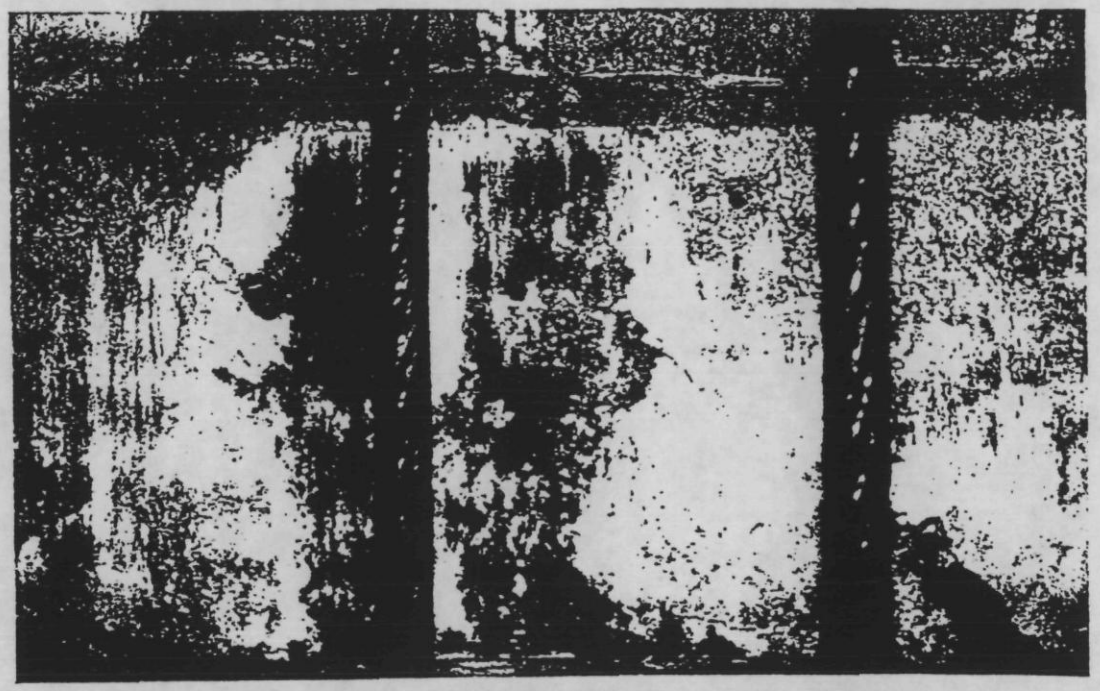
Photo 42	2WTC	Shaft 20B	-	Col. -	Deterioration of fireproofing due to counterweight cable Exposed steel with light surface rust Typical throughout shaft

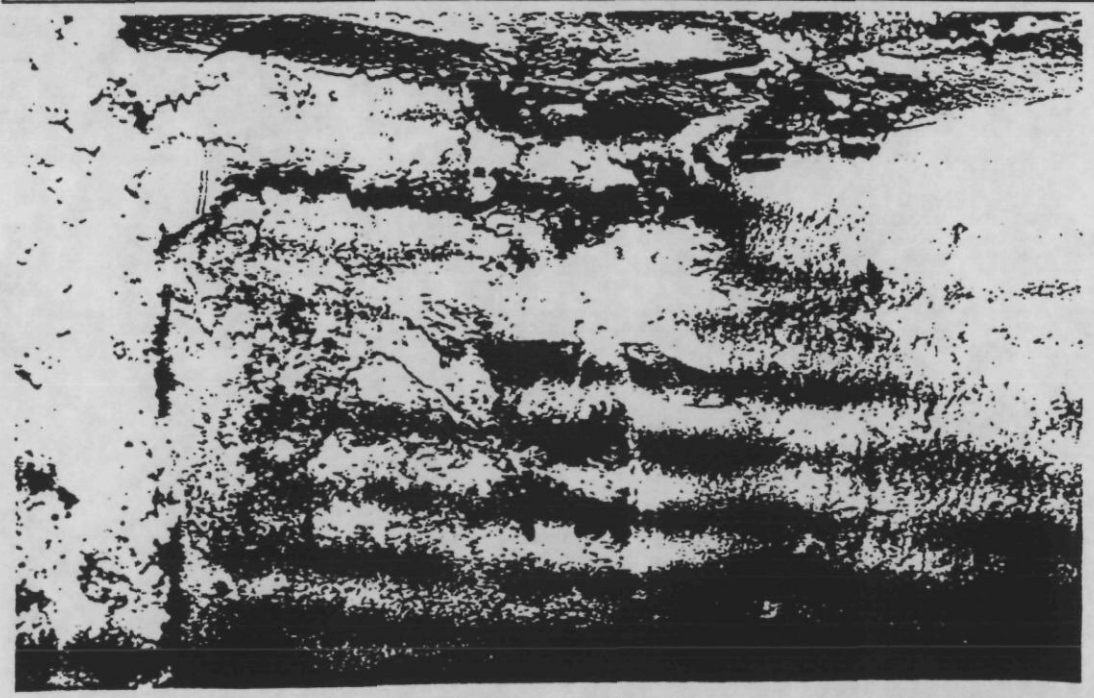
Photo 64	2WTC	Shaft 89B	82	Col. 702	Deterioration of fireproofing at beam intersection at corner of shaft Bolts and web of beams exposed Typical throughout shaft

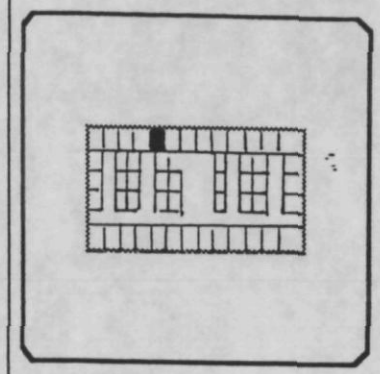
FINDING:
Deterioration of erection bolt ends and fireproofing on connecting beams due to rubbing of the compensation rope

RECOMMENDED ACTION:
Repair fireproofing per Appendix E
PANYNJ to eliminate or reduce cable sway using a cable damping device

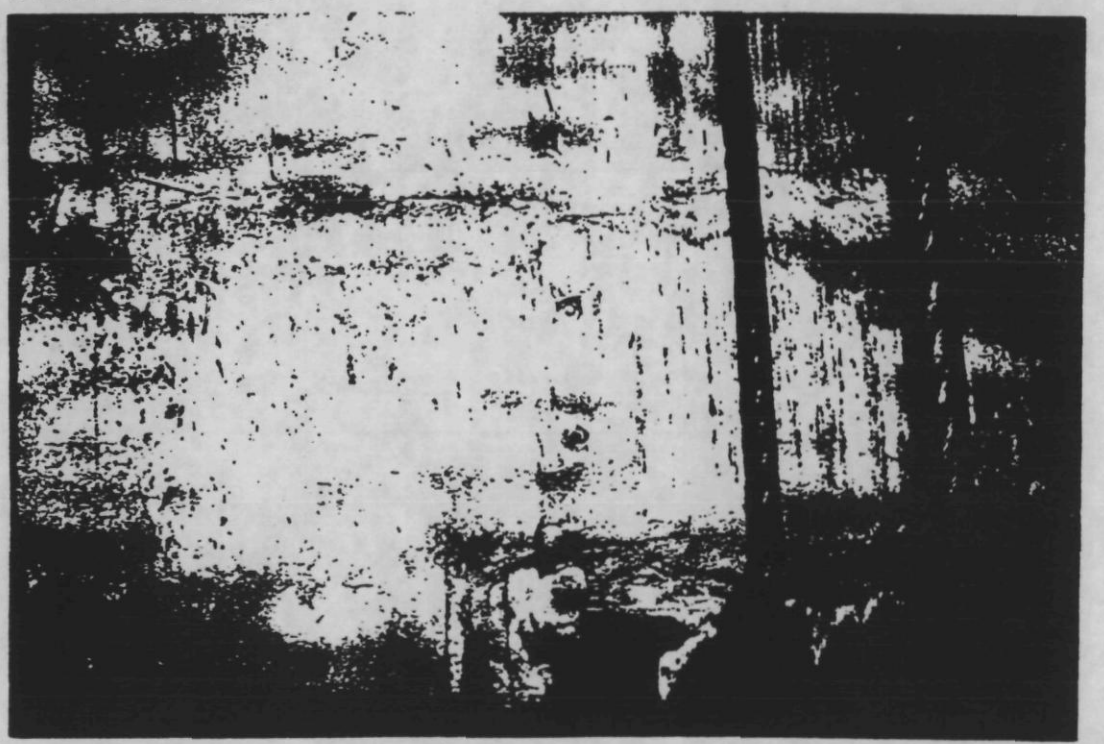
Photo 4	Deterioration of fireproofing ~~on connecting beam due to compensation rope~~ rubbing against beam and bolt ends Steel plate partially exposed with light surface rust

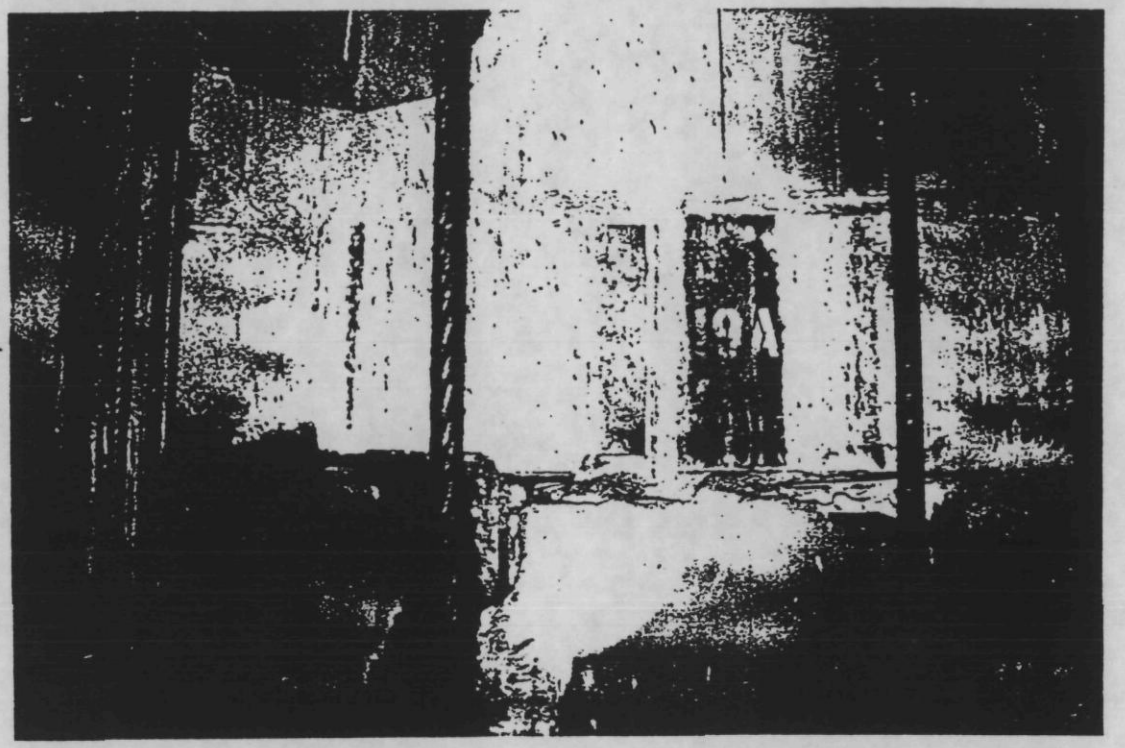
Photo 8	Exposed steel with light rust at column, connection plate and connecting beam Deterioration of fireproofing on beam due to compensation rope Varying degree of damage to beam fireproofing throughout the shaft

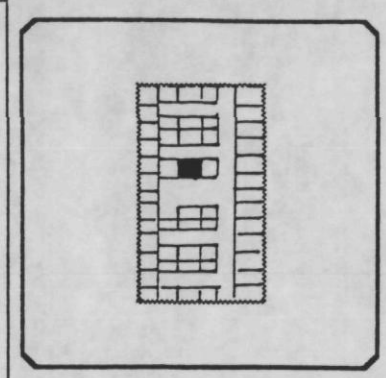
We observed in elevator shaft 34B, two damaged beams located at the bottom of floor 9 and floor 10. The web and flange of the beams were warped. The source of the damage is unknown. We recommend that testing be done on the two beams.

ITEM: 14 (Sheet 1 of 6)	URGENCY: Priority	Location of Finding
LOCATIONS: 2WTC Elev. Shaft 34B Bottom of Floor 9 & Floor 10 **FINDING:** Web of beams warped. **RECOMMENDED ACTION:** Beam testing by laboratory Add stiffeners to web of beam as a minimum repair per Fig. 14

DESCRIPTION:
We observed damage to the web and bottom flange of the beams located in 2 WTC, elevator shaft 34B. The beams are located at the bottom of floor 9 and the bottom of floor 10. The east end of the beam at the bottom of floor 10, there are 3 locations of web warping (See Fig. 14-3).

ITEM	DESCRIPTION	LOCATION
14	Beam testing by laboratory Add stiffeners to web of beam as a minimum repair per Fig. 14	2WTC Elev. Shaft 34B Bottom of Floor 9 & Floor 10

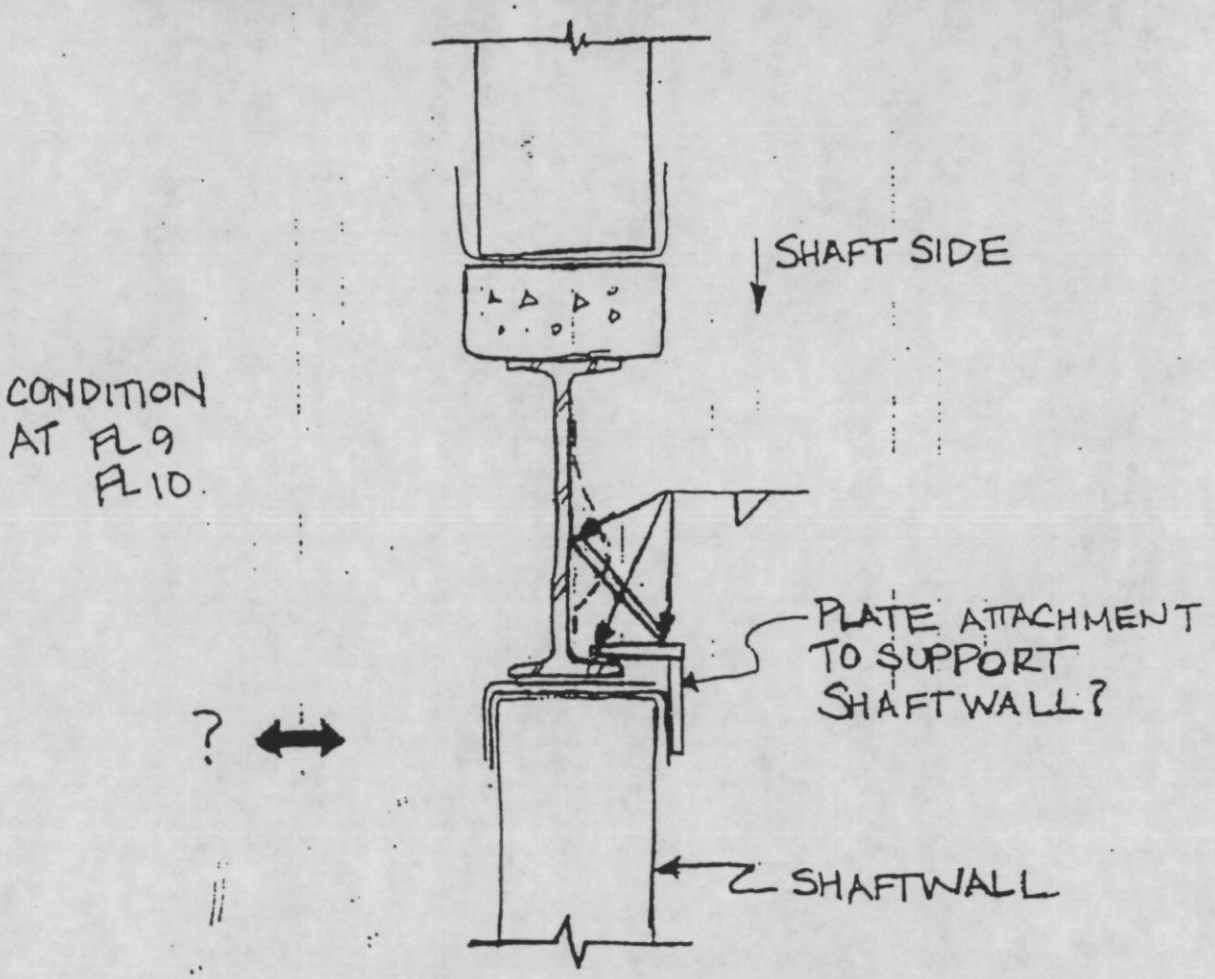
SECTION a-a

POSSIBLE CAUSE OF WEB WARPING

- UNKNOWN FORCE ACTING ON OTHER SIDE OF SHAFTWALL
- WARPING CAUSED BY FIRE IN THE 70's.

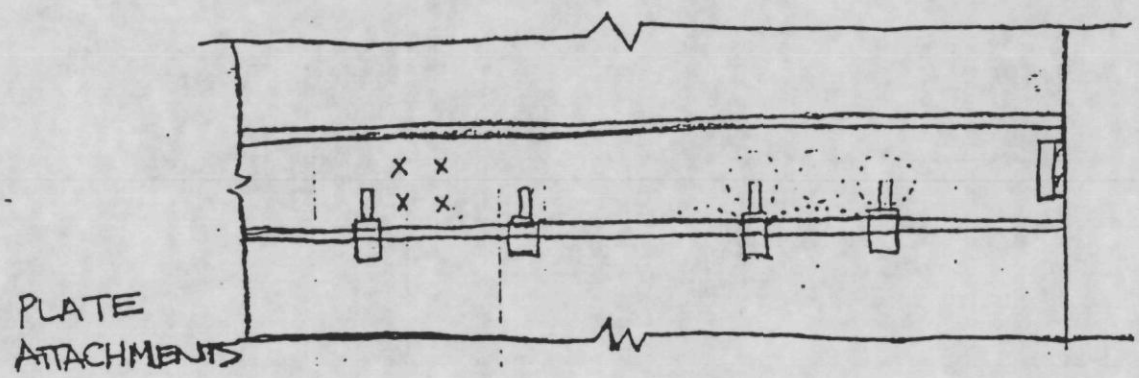
--- LINE OF WARPING
SECTION b-b

EXISTING CONDITION @ FL.10

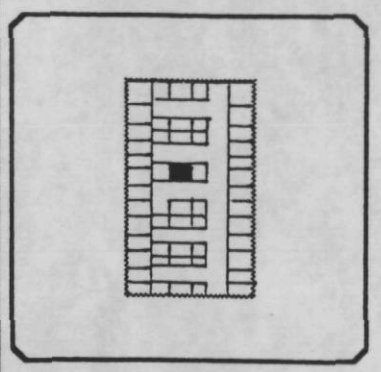
FINDING:
Fire protection appears to be compromised due to reworking of wall

RECOMMENDED ACTION:
Fire rating should be investigated
Repair wall where fire rating of wall has been compromised
